JOURNAL OF RADIOGRAPHY AND RADIATION SCIENCES

A SURVEY OF DIAGNOSTIC X-RAY ROOM DESIGN AND SHIELDING INTEGRITY OF LEAD APRONS IN A STATE IN NORTH EASTERN NIGERIA.

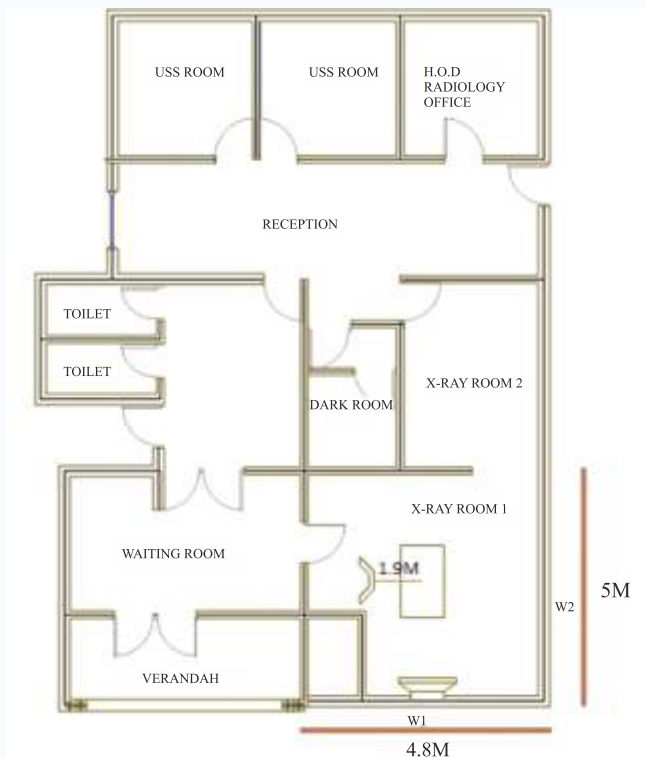
Figure 1: Radiology department layout for facility A

Facility A (figure 1) had two x-ray room, with functional and non-functional x-ray machine. The room with functional x-ray machine had a dimension of 24m² with distance of 1.9m from the x-ray tube to the control panel (Tables 1a). A 2.0 mm lead sheet bonded to plywood was used as the shielding material.

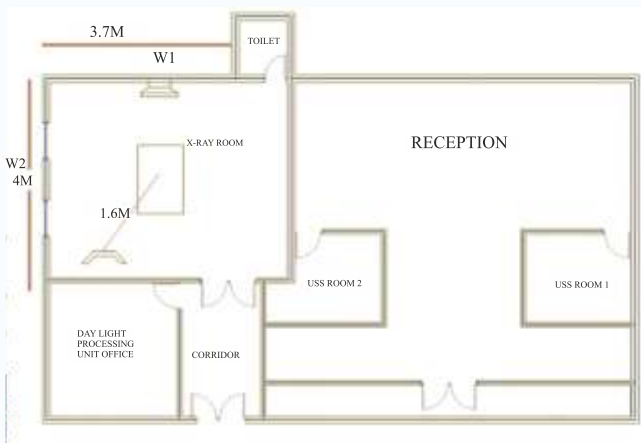
Figure 2: Radiology department layout for facility B

Facility B (figure 2) had an x-ray room dimension of 14.8m² with distance of 1.6m from the x-ray tube to the control panel (Tables 1a). A 2.0mm lead sheet bonded to plywood was used as the shielding material.

Facility B however, did not meet any of the standards. According to the inverse square law, the larger the room dimension; the more distance would be between the x-ray tube and the control panel, the lesser the radiation that will reach the operator and the wall of the radiographic room. Some corrective measures such as enlarging the size of x-ray room etc. are recommended for facility B, to prevent increased radiation exposure to personnel. Time, distance and shielding are well-established dose reduction strategies in radiography. Measurement of distances in diagnostic radiography is of great significance, as the intensity of radiation decreases as the square of its distance from the source, according to the inverse square law [6]. Apart from decreasing the intensity of radiation, maximized distance also helps to minimize the cost of shielding, and also has clinical significance as it aids in proper patient positioning and geometric display of anatomy of interest and pathology on radiographs [6]. All the

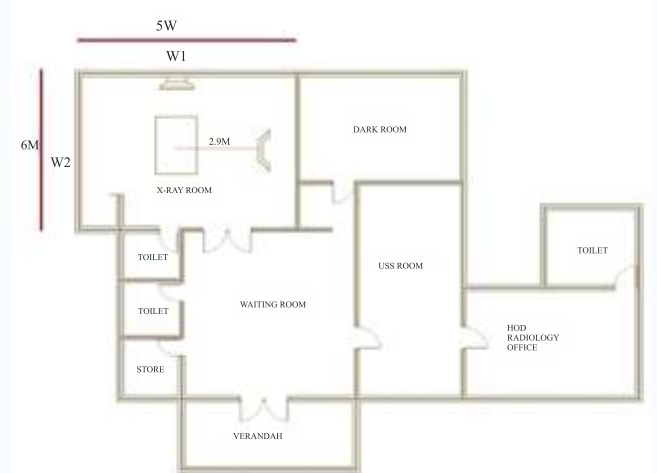
Figure 3: Radiology department layout for facility C

Facility C (figure 3) had an x-ray room dimension of 30m² with distance of 2.6m from the x-ray tube to the control panel (Tables 1a). A 2.0mm lead sheet bonded to plywood was used as the shielding material.

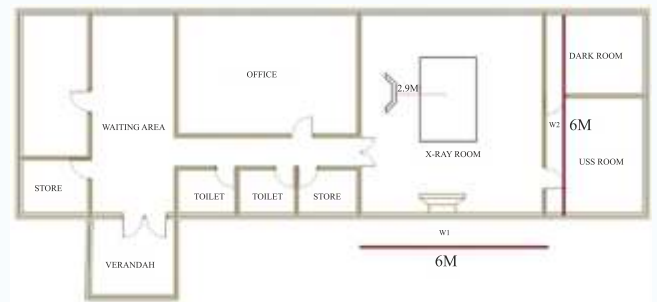
Figure 4: Radiology department layout for facility D

Facility D (figure 4) had an x-ray room dimension of 36m² with distance of 2.9m from the x-ray tube to the control panel (Tables 1b). A 2.0mm lead sheet bonded to plywood was used as the shielding material.

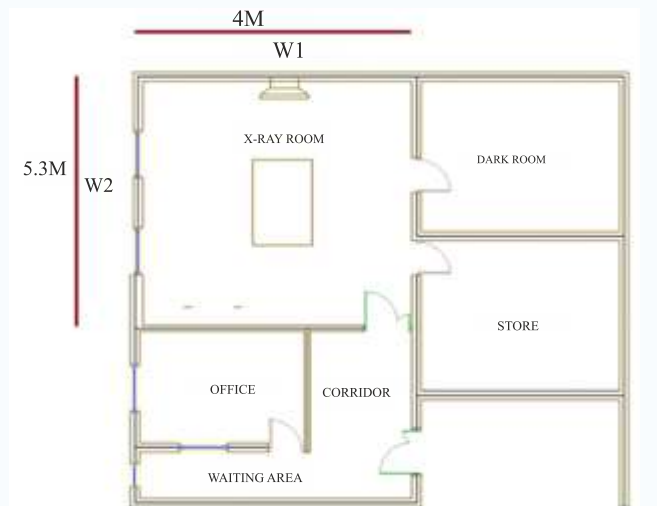
Figure 5: Radiology department layout for facility E

Facility E (figure 5) had an x-ray room dimension of 21.2m² with no control panel (Tables 1b). The wall was not lead lined, but however a block/cement with a thickness of 0.45m is used instead.

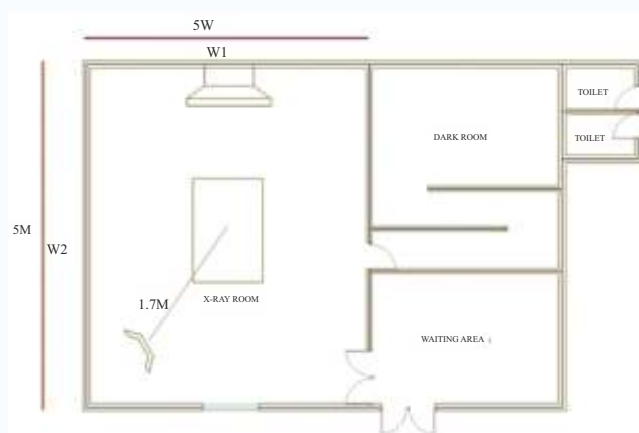
Figure 6: Radiology department layout for facility F

Facility F (figure 6) had an x-ray room dimension of 25m² with distance of 1.7m from the x-ray tube to the control panel (Tables 1b). The wall was not lead lined, but however a block/cement with a thickness of 0.3m is used instead.

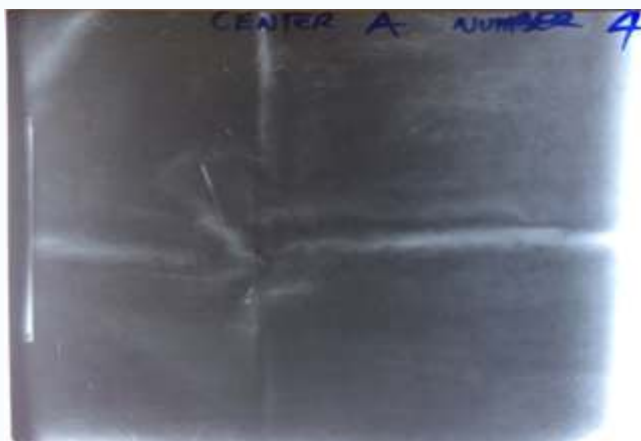
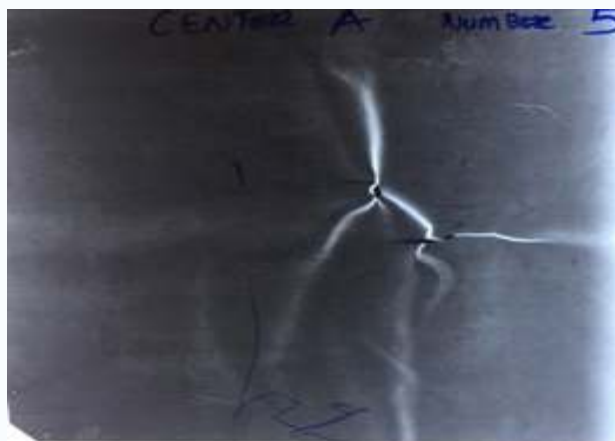
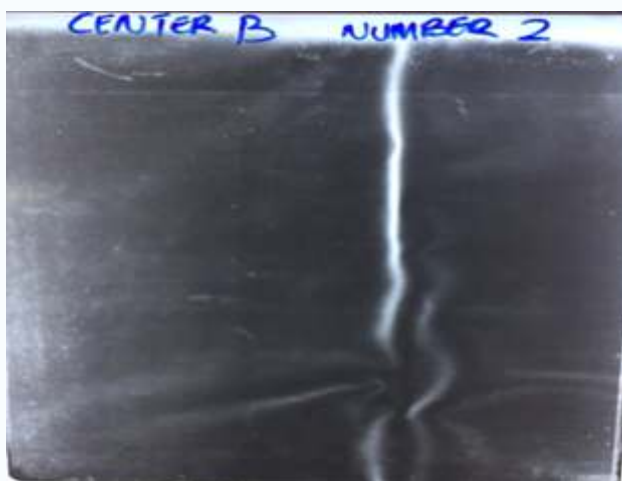
Figure 8: Result on Checks of some Apparel

The result in table 3 showed that 7 (38.8%) of apparels (lead aprons) inspected were defective, while 11 (61.1%) were not defective. The finding of this study is similar to the study conducted by Nkubli *et al.*, (2013) on quality control in radiology units' of tertiary healthcare centers in north eastern Nigeria.
